USATEA REPORT 66-11

Engineering Report

# PERSHING TRANSPORTABILITY STUDY

Foreign Railways, Vol. III of IV

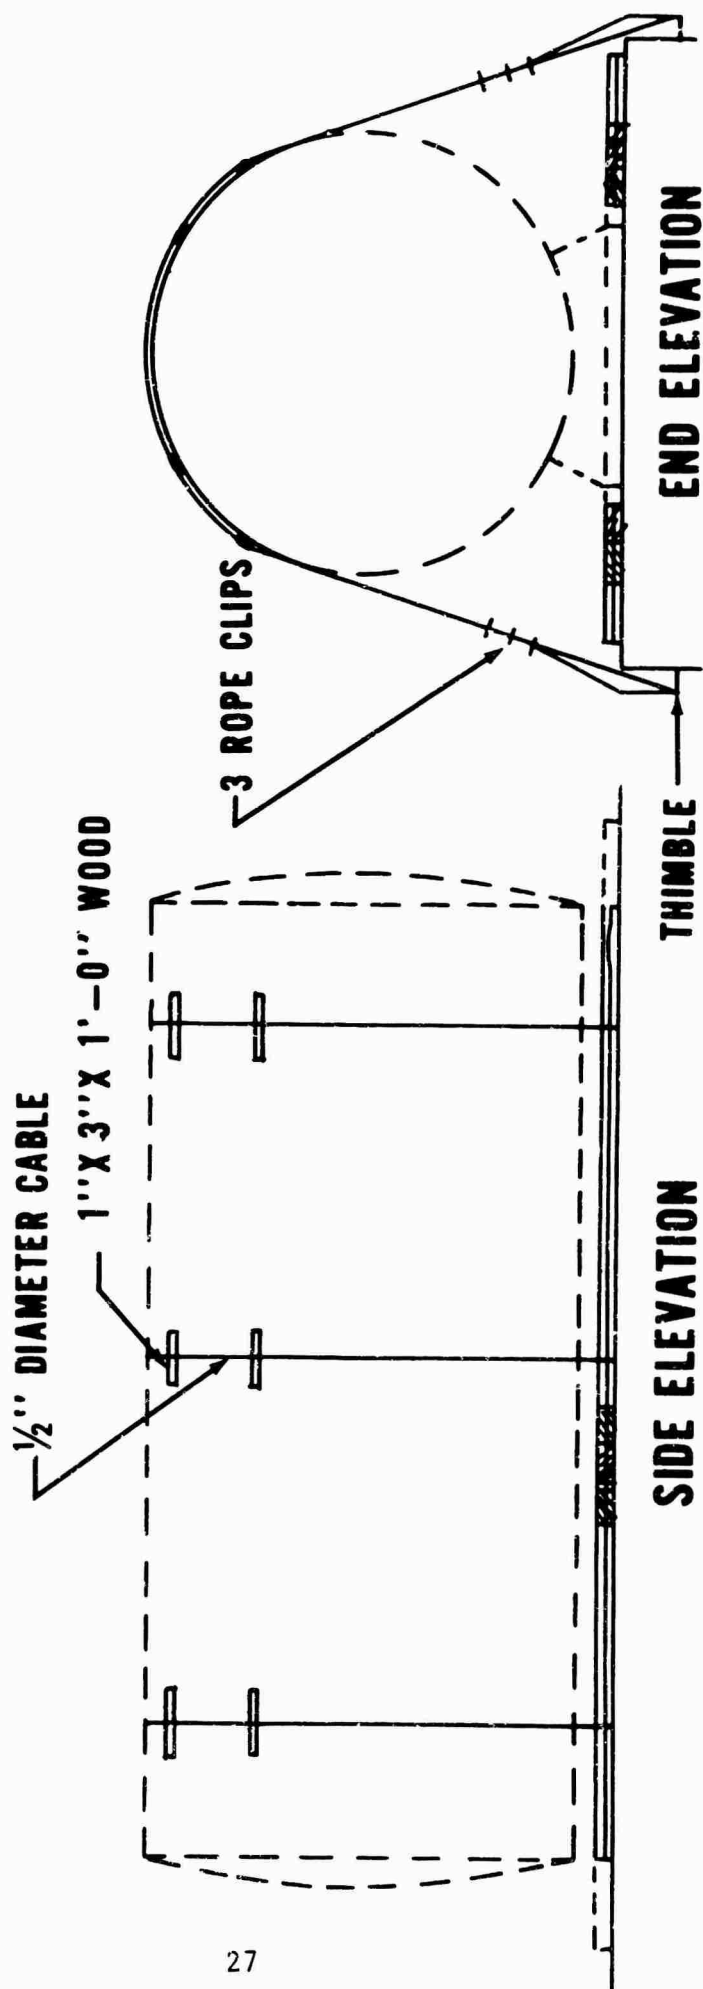
1. Only two cables are required for the XM 474.
2. If available, 2"x.05" steel strapping, doubled, may be used in lieu of cable. If used: seal lap joint with two seals, two crimps per seal; provide antichafing material (canvas) at all points of contact with container; protect all straps at bottom of stake pockets with 12-to-16 gage sheet metal or equivalent.

Figure 18. Vertical Restraint for XM 474, XM 475, and XM 476 Containers.

A distributed uniform loading arrangement that is applicable to the XM 474, XM 475, and XM 476 containers was developed. See Figures 17 and 18. In addition to replacing the many arrangements depicted in Savanna Army Depot Drawing No. 5425, the arrangement shown in Figures 17 and 18 offers the following advantages over the arrangement illustrated in Figure 11:

In view of its simplicity and the other advantages enumerated, the restraining arrangement illustrated in Figures 17 and 18 is recommended for rail shipment of the XM 474, XM 475, and XM 476 containers.
